SAFETY DIGEST

Lessons from Marine Accident Reports

1/2024

MARINE ACCIDENT INVESTIGATION BRANCH

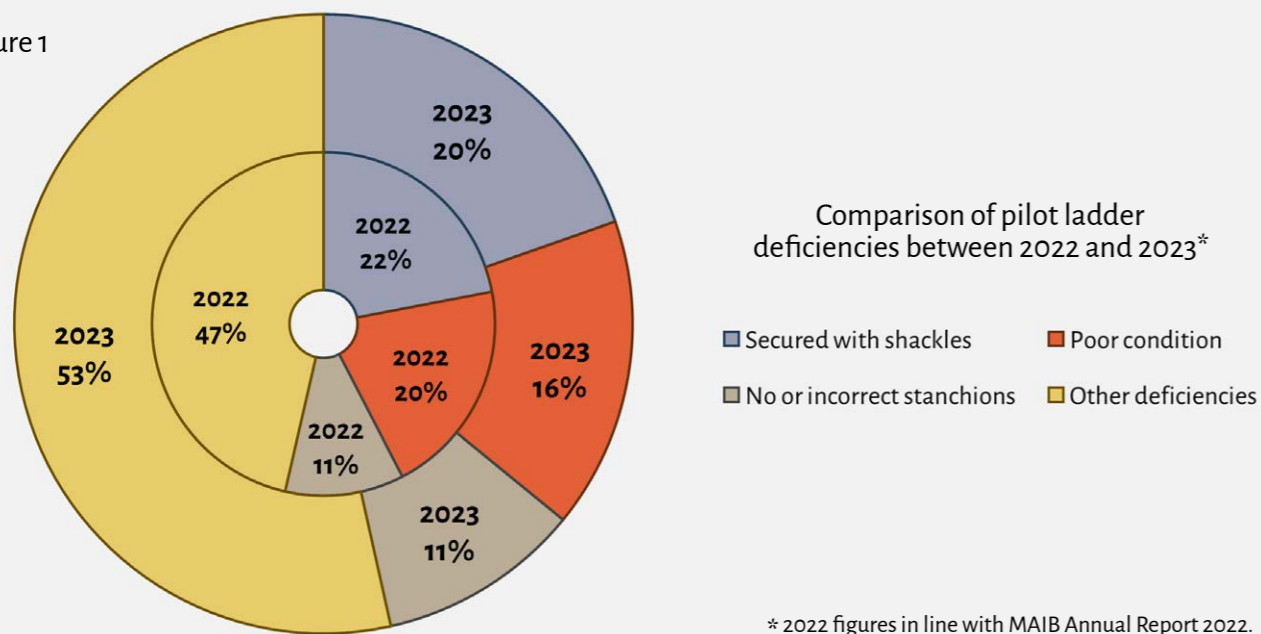
Figure 1

Approximately 50% of all pilot ladder incidents reported to us in 2023 involved the same three deficiencies as those reported during 2022 (Figure 1), the leading deficiency once again being pilot ladders secured using shackles over the side ropes (Figure 2). Also known as 'choke shackles', this arrangement brings the entire weight of the ladder onto one step, which is not designed to take a weight that should be borne by the side ropes. As in 2022, the next most common deficiencies were the ladder being in poor condition or having no or incorrect stanchions (Figures 3 and 4).

- Inspect** → Examine the ladder at regular intervals and before each use to identify damaged or degraded parts and replace it as necessary. Make sure there are sufficient spares of a suitable quality on board.
- Check** → Secure the ladder to strong points using manila rope tails tied in a rolling hitch around both side ropes. Do not use shackles to secure the side ropes.
- Check** → Make sure the stanchions at the top of the climb allow the pilot to gain a firm grip during the transition between deck and ladder.
- Confirm** → Test the ladder to be certain it remains secure when weight is applied. Pilots are not always able to check this themselves, particularly during inclement weather.

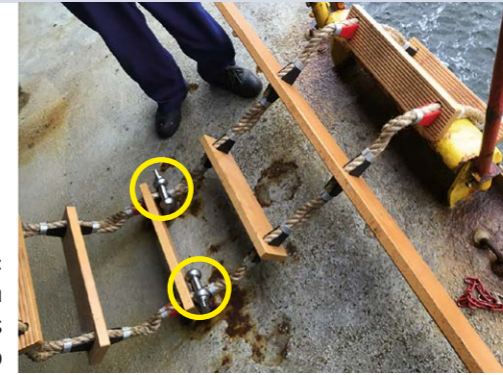
Figure 2: A pilot ladder reported in 2023, showing the shackles against the step

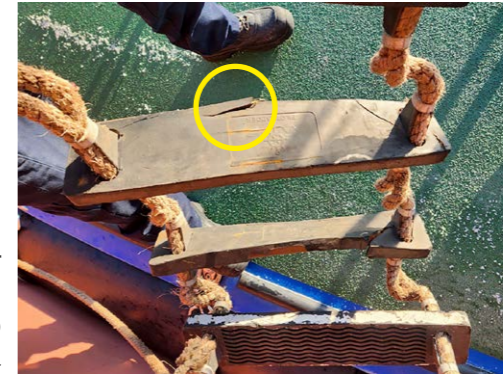
Figure 3: Cracked, warped rubber steps and worn side ropes. The ladder also appears to have been painted

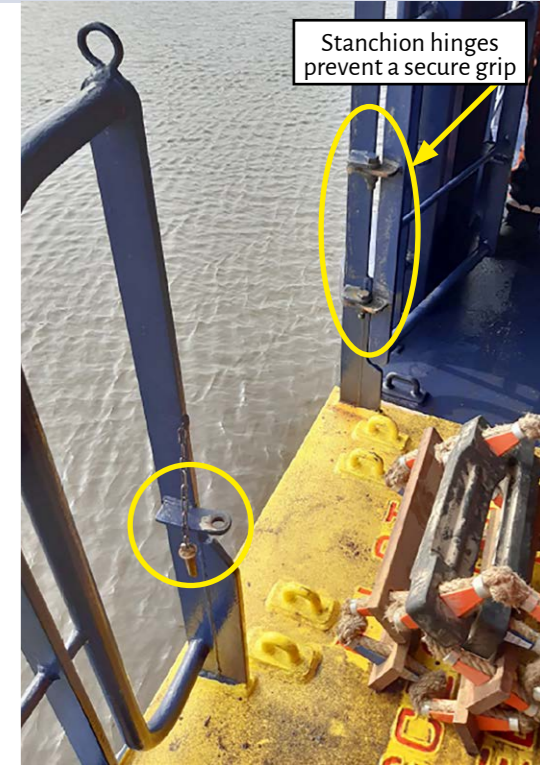
Figure 4: An access gate without suitable stanchions for the pilot to gain a secure grip

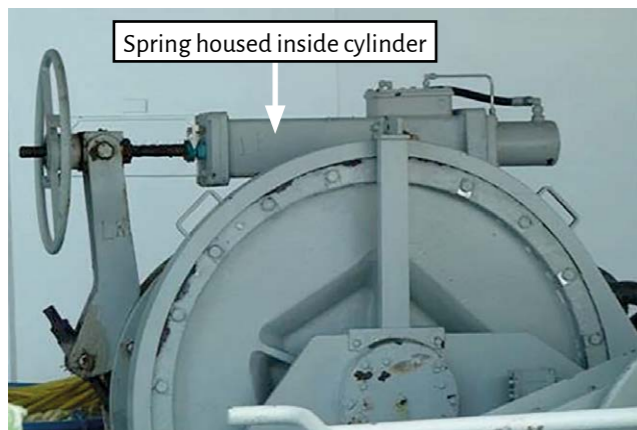
Figure 1: Anchor cable brake assembly

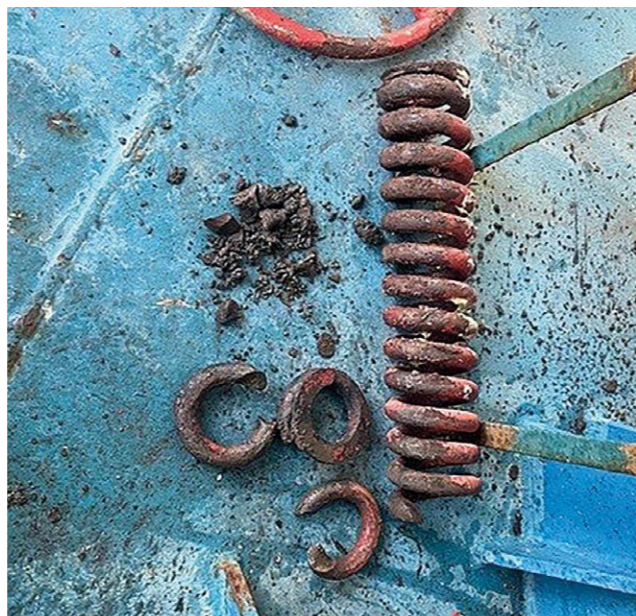
Once the ferry was safely alongside, an examination of the anchor cable brake assembly found that the spring (Figure 2) inside it had fractured in several places and rendered the brake inoperable. The company's technical supervisor was on board at the time and a temporary solution was soon agreed with the classification society and the port authority. The ferry's crew and passengers were uninjured during the incident and there was no other material damage.

Figure 2: The broken anchor cable brake spring

- Equipment** → Corrosion inside the anchor cable brake assembly led to pitting on the spring, which became the initial point of fracture. The routine exposure of equipment to the elements increases its risk of failure and regular checks and maintenance are essential to prevent this.

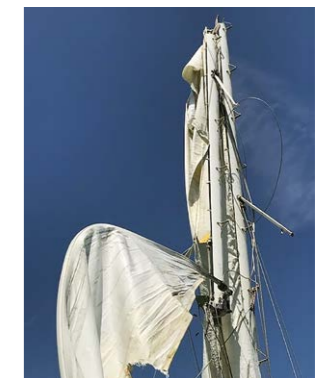
The yacht scraped along the port side of the dredger, damaging its masts and sails as it did so (see figure), but fortunately remained afloat. The dredger's crew rendered assistance before the yacht made its way back to port.

Figure: The damage

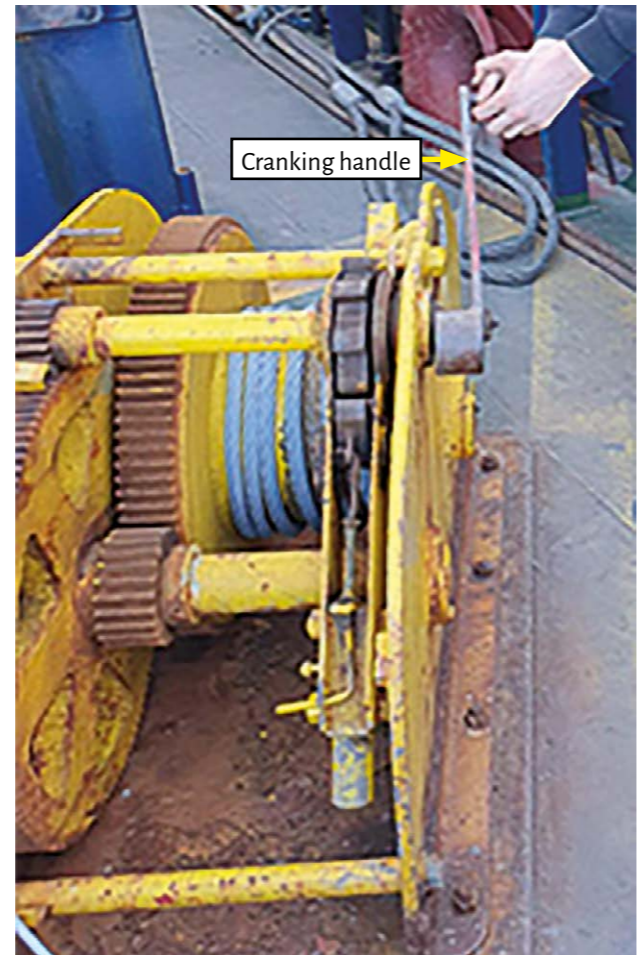
When the winch brake was released the tension in the line connected to the cargo barge caused the winch drum, and still attached cranking handle, to spin uncontrollably. The spinning cranking handle violently struck one of the crew members, fracturing their wrist and inflicting significant pain (Figure 2). The crew member was evacuated from the tug by a Royal National Lifeboat Institution (RNLI) lifeboat and

Figure 1: The coupling winch and removable cranking handle

1. **Risk** → The pusher tug's crew might have identified the risk posed by the hazard of the still attached cranking handle had they collectively taken a moment to undertake a dynamic risk assessment rather than rush to complete the task. Empowering crew to identify hazards, assess the risks involved and report their concerns contributes to a proactive on board safety culture and reduces the likelihood of accidents.
2. **Monitor** → The master could not safely undertake the simultaneous tasks of steering the pusher tug and trying to control the aft deck operations from a position of limited visibility. The use of the closed-circuit television (CCTV) to provide operational oversight from a remote position can help to identify any safety issues and take immediate preventative action.

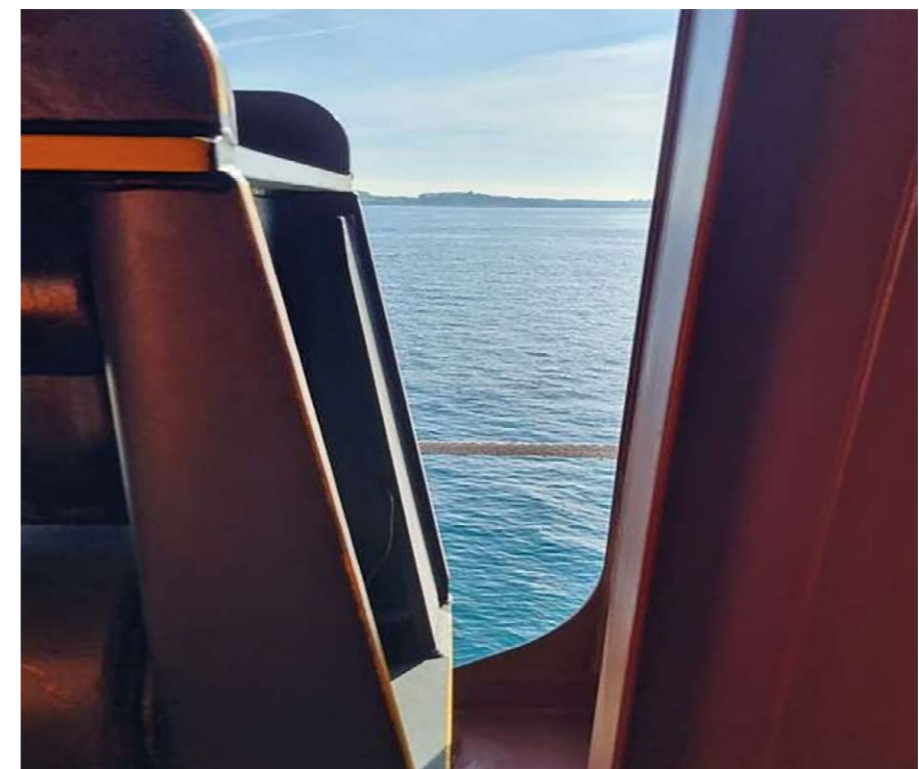
Figure 1: The unguarded opening at the time of the incident

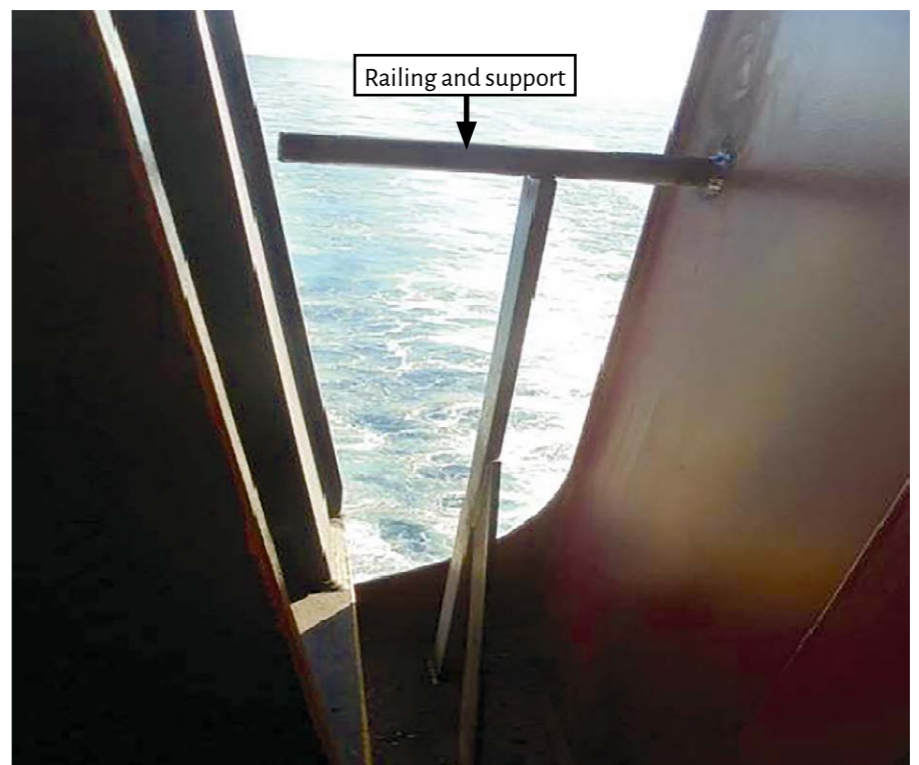
The company's subsequent accident investigation identified the hazard of the unguarded opening and took swift remedial action to fabricate and install a railing and support to mitigate the risk (Figure 2). The company also issued a fleetwide safety bulletin to highlight the accident, and required each vessel to undertake an immediate mooring area hazard assessment to prevent similar incidents in the future.

Figure 2: The guarded opening following remedial action

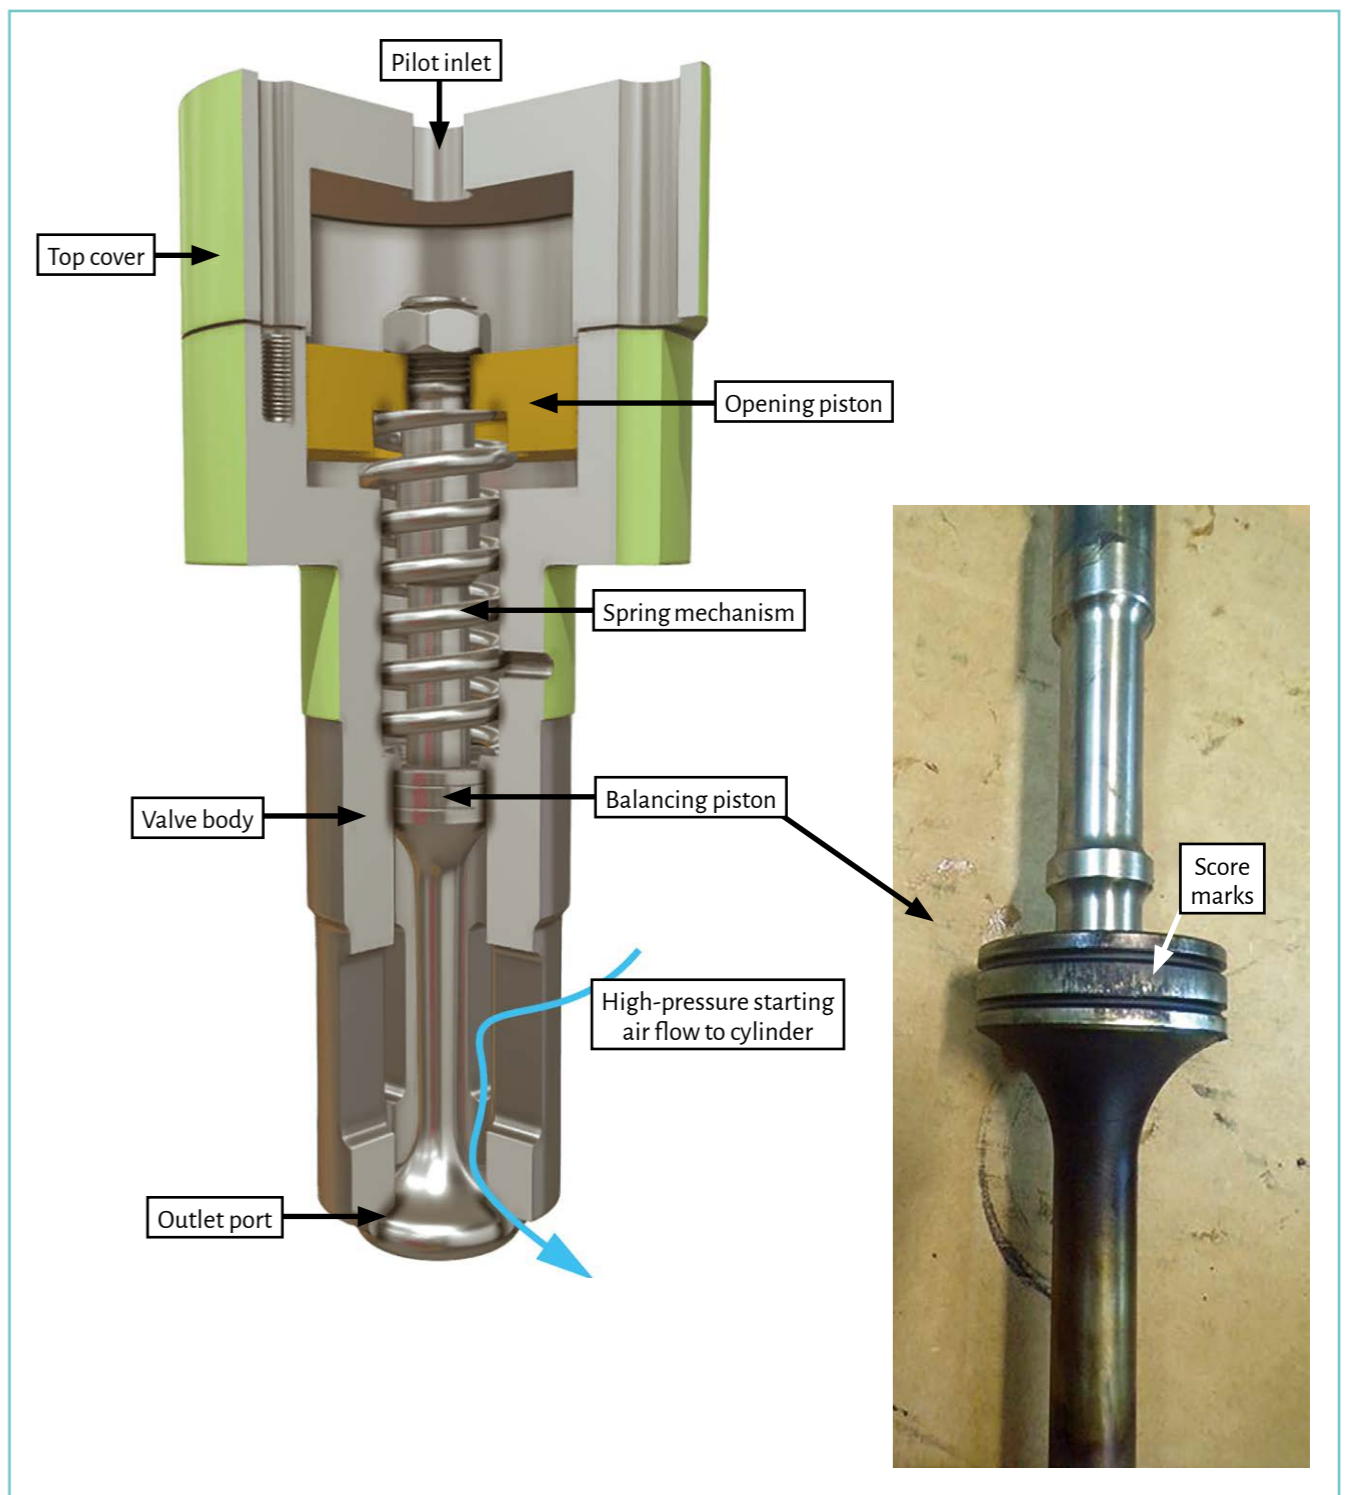
Disassembly of the air start valve found that cylinder combustion gases had leaked into the body of the air start system and scored the balancing piston, causing it to overheat and seize (see figure). The valve was replaced with a spare carried on board, after which the engine was tested and was once more able to run both ahead and astern.

- Hazard** → Air start valve leakage presents a considerable risk. While the failure in this case prevented the engine from starting, leakage of hot combustion gases into the air start system introduced the risk of a starting air system explosion. Early detection and remedy is vital to maintain a safe engine room environment and prevent devastating consequences.

Figure: Cross-section of an air start valve and (inset) the seized balancing piston

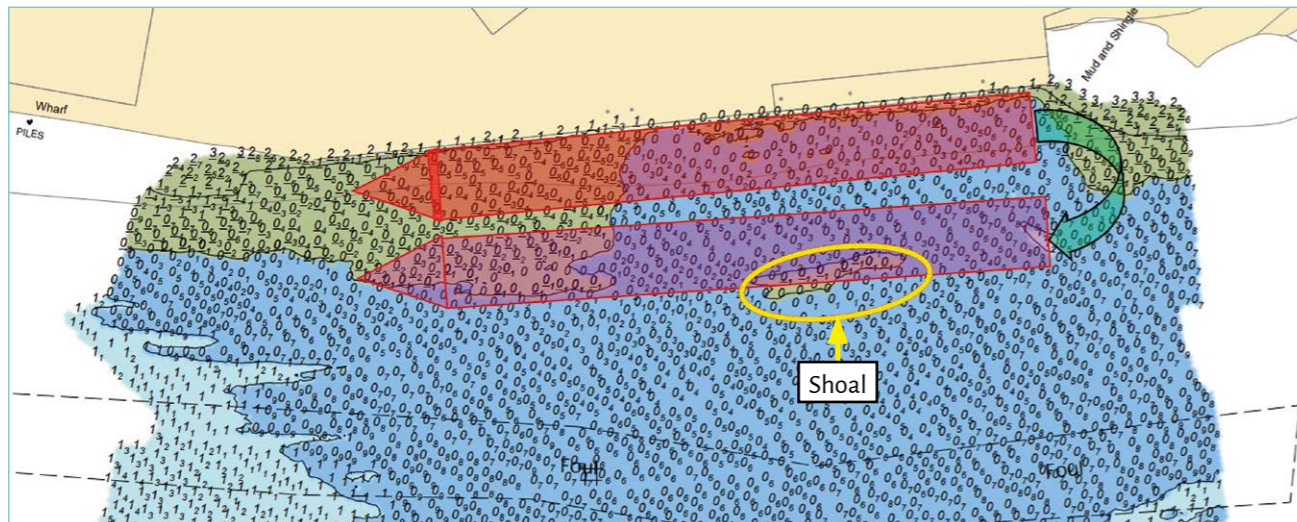
Following some rapid hydrographic survey work it became clear that the slope of the riverbed at the NAABSA berth had changed. The mud was now on an incline and was serving to draw ships away from the quayside. The resulting strain on the mooring lines was too much when the vessel settled aground. On parting, the mooring lines snapped back some 40m at their greatest extent. Dredging quickly resolved the primary cause of this accident by levelling off the riverbed adjacent to the quay.

Figure 1: The cargo vessel resting on the shoal

1. **Monitor** → For a NAABSA berth to be safe to use it needs to be flat and without any significant incline. A riverbed can easily change its profile following heavy rain, extended dry periods or due to significant building works either up or downstream. Regular surveys of the berth area are necessary to determine the profile and depths and whether any debris is present that might cause a hazard. The last survey in this case had been carried out 6 months before the incident but there had been heavy rainfall in the intervening period.

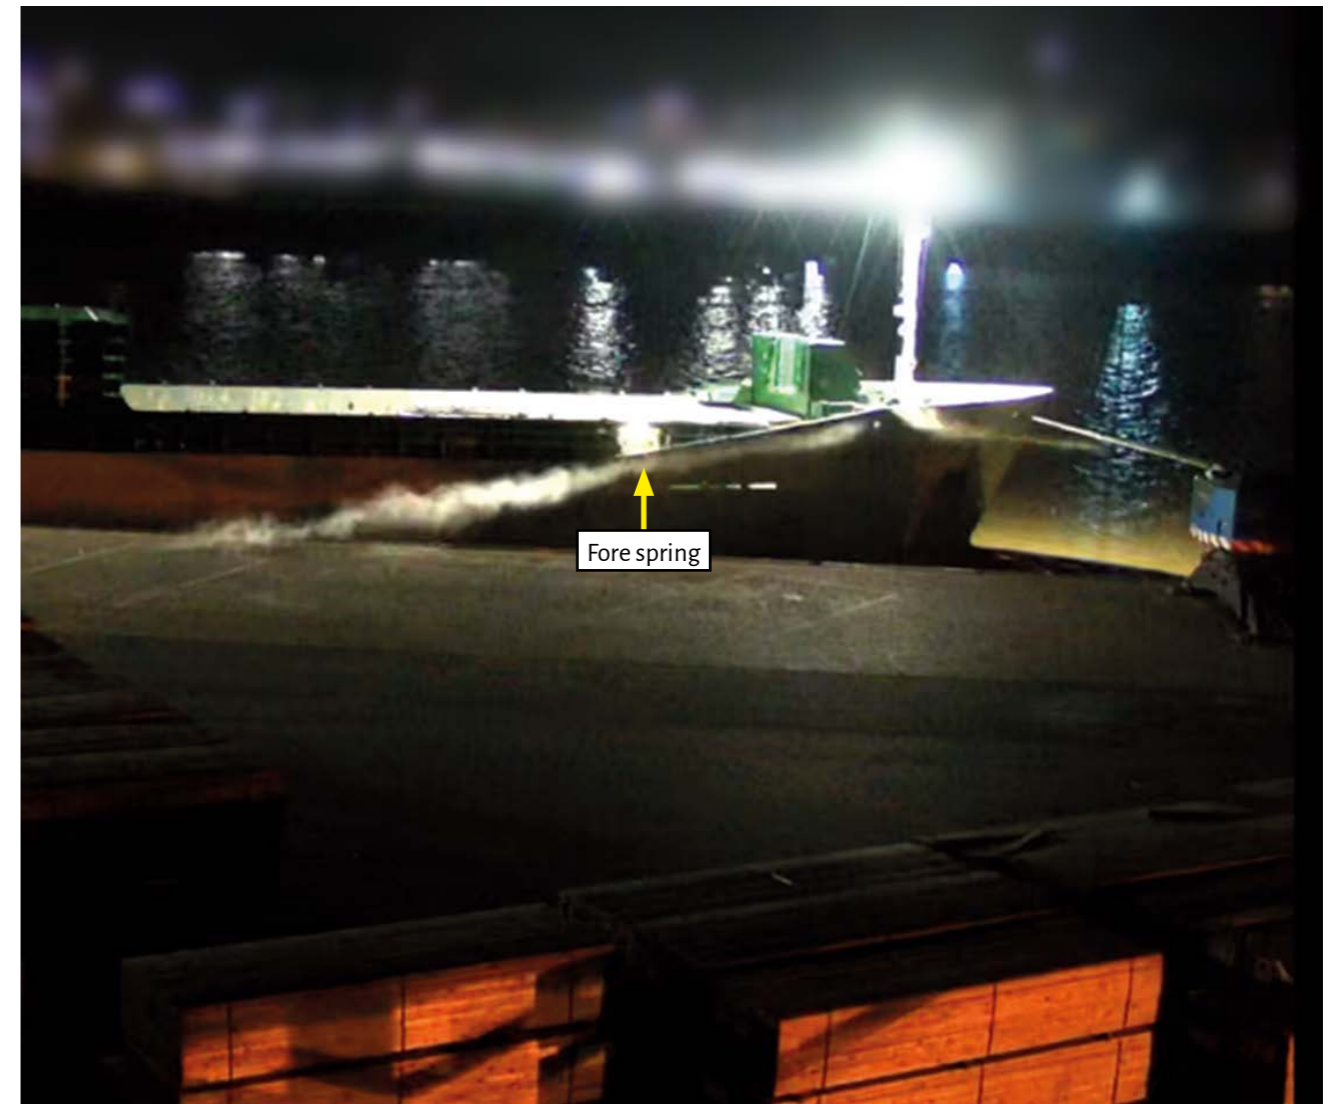
Figure 2: Video still, showing the moment the fore spring snapped

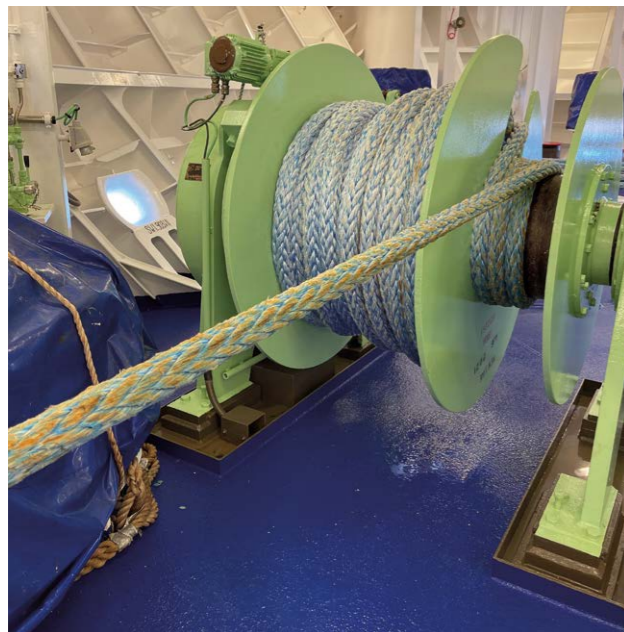
Figure 1: The winch drum

1. **Margin of safety** → Exercise caution around moving machinery. Avoid getting too close to rotating equipment and ensure that loose clothing or any objects that can become caught in it are kept clear. The long messenger line used to guide the mooring rope was able to reach the deck and wrap itself around the AB's leg, leading to the accident. Maintaining a safe distance from the winch drum is essential to prevent such incidents.

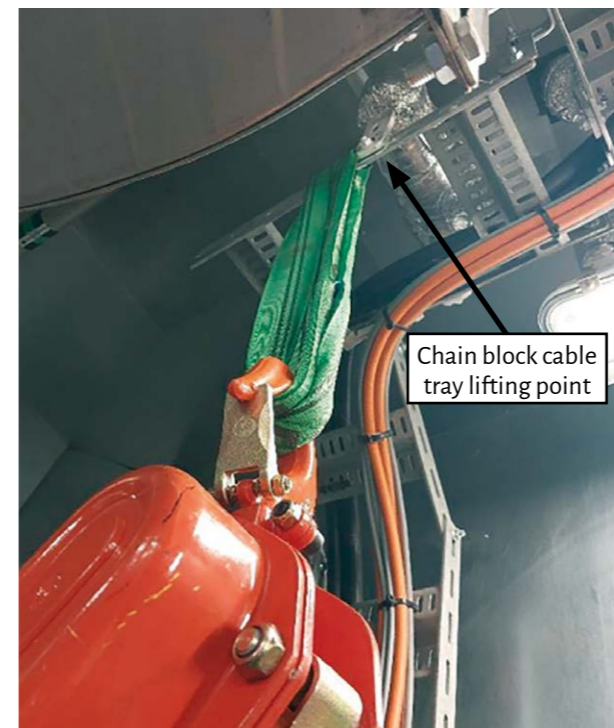
Post-incident examination of the lifting arrangements found that only one of two 980kg working load limit deckhead fixed rings had been used, along with lifting attachment points to a cable tray (Figure 2) and a pipe bracket. Additionally, the chain blocks used for lifting the

Figure 2: The cable tray lifting point

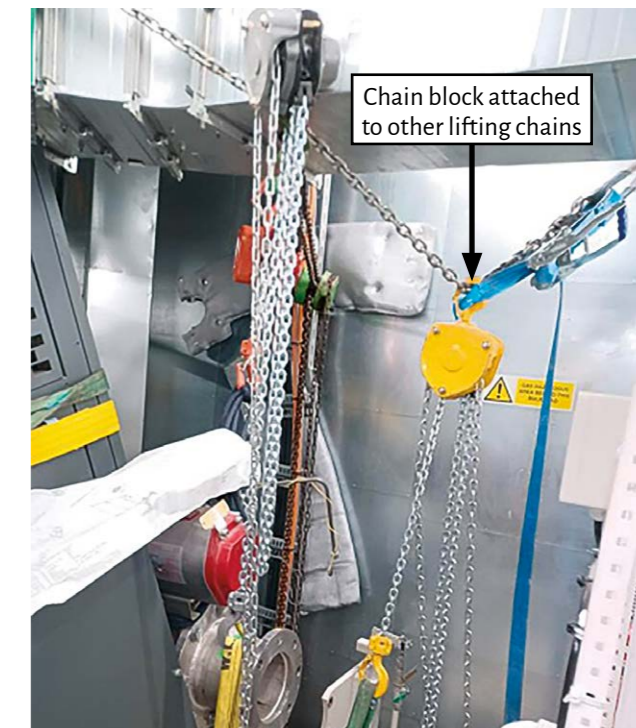
aft end of the compressor were hooked on to the chains of other chain blocks (Figure 3). The steel bars did not have any spreader arrangements and the wide forklift truck 'lifting slots' allowed movement of the bars.

Figure 3: The lifting arrangements

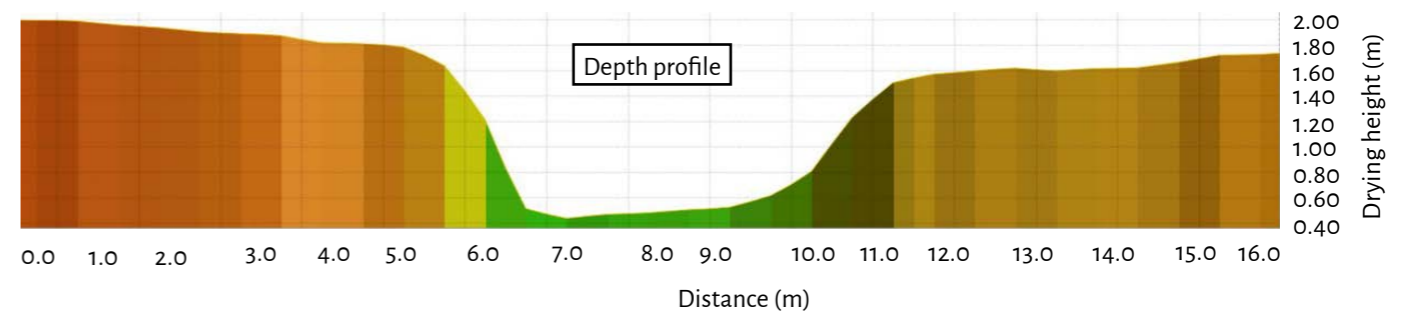
Figure 2: Hydrographic survey data, showing the bow imprint in the mud

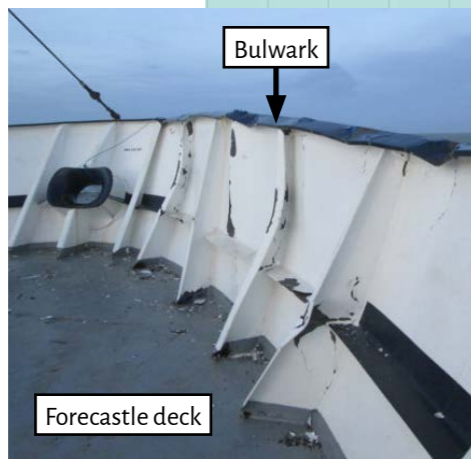
The cargo ship sustained damage to its foredeck bulwarks (Figure 2) and the LNG carrier incurred minor scrapes to the ship's side. Fortunately, only the C/E's pride was hurt.

Figure 2: Damage to the bulwark

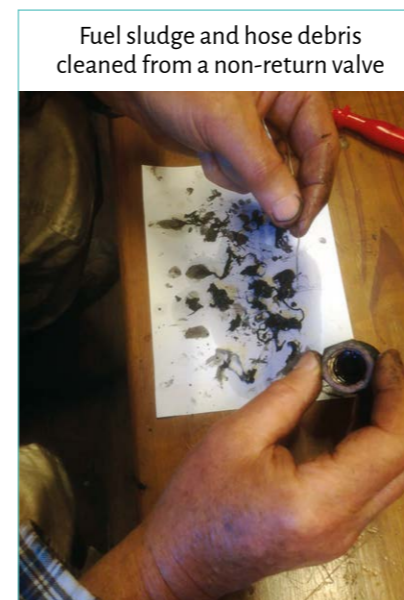
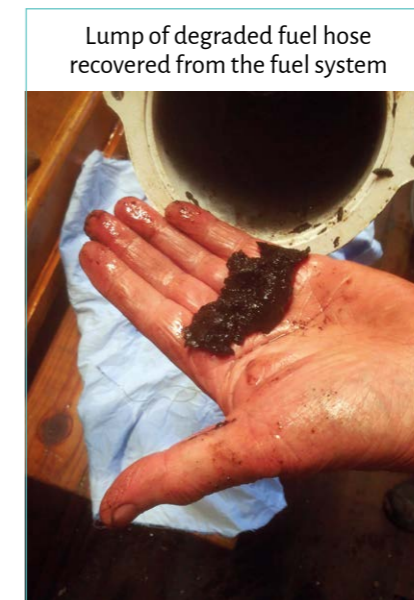
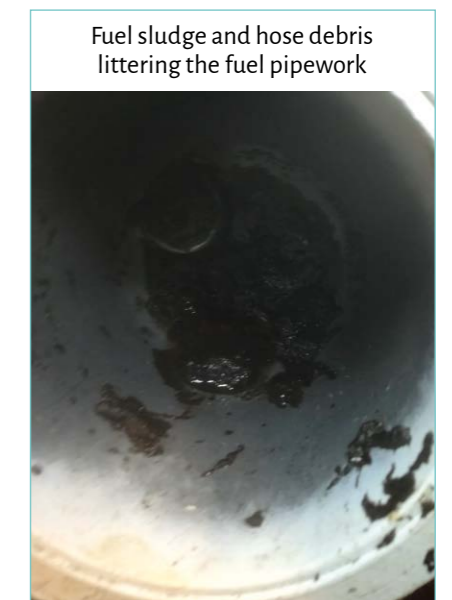
Realising that the vessel was being set towards danger, the skipper called for assistance. The heritage vessel was later towed to a nearby harbour where the main engine and generator were stripped down and examined. Many of the fuel system's flexible hoses were found to have degraded, resulting in flaps of rubber detaching from the internal walls and acting like non-return valves. Fuel sludge had also clogged the pipework throughout the engine and generator systems (see figure).

Figure: The clogged pipework

- Maintain** → Flexible hoses are prone to degradation. It is important to make sure there is compatibility between hose types and fuels and frequently check, and where necessary replace, hoses.

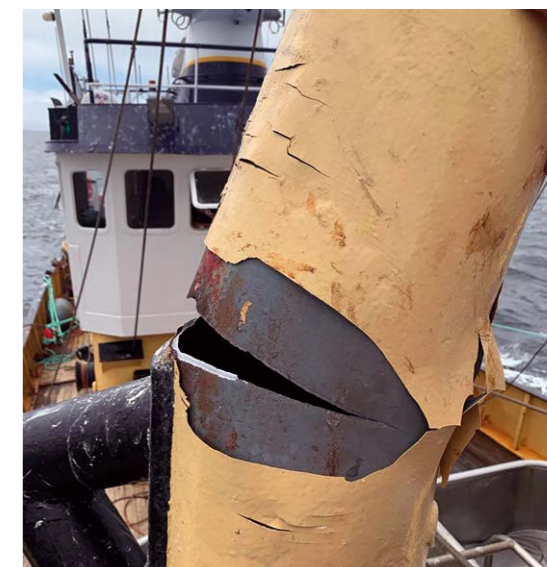
Figure 2: One of the cracks in the derrick posts

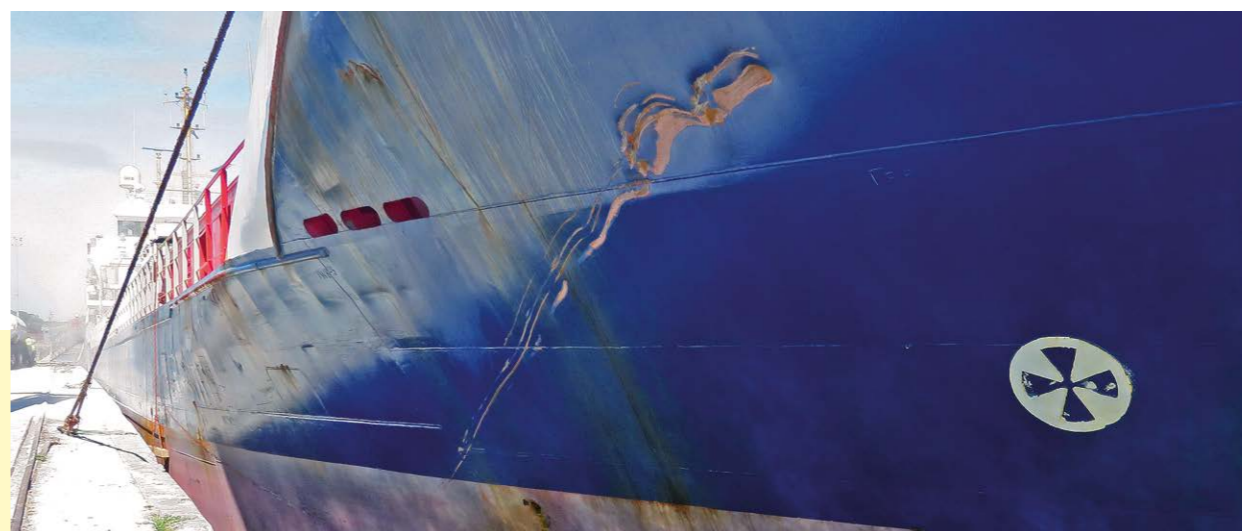
Figure 3: The area of plate damage

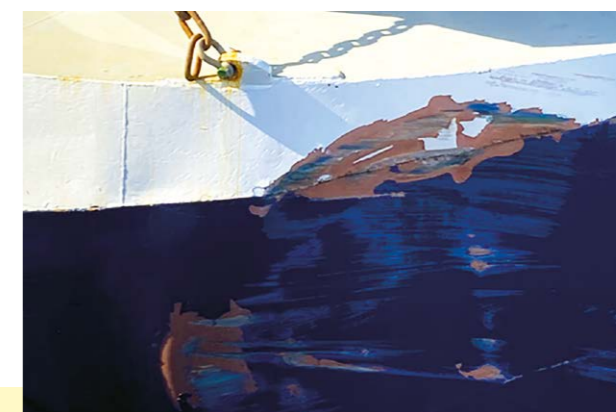
Figure: Damage to the beam trawler's bow

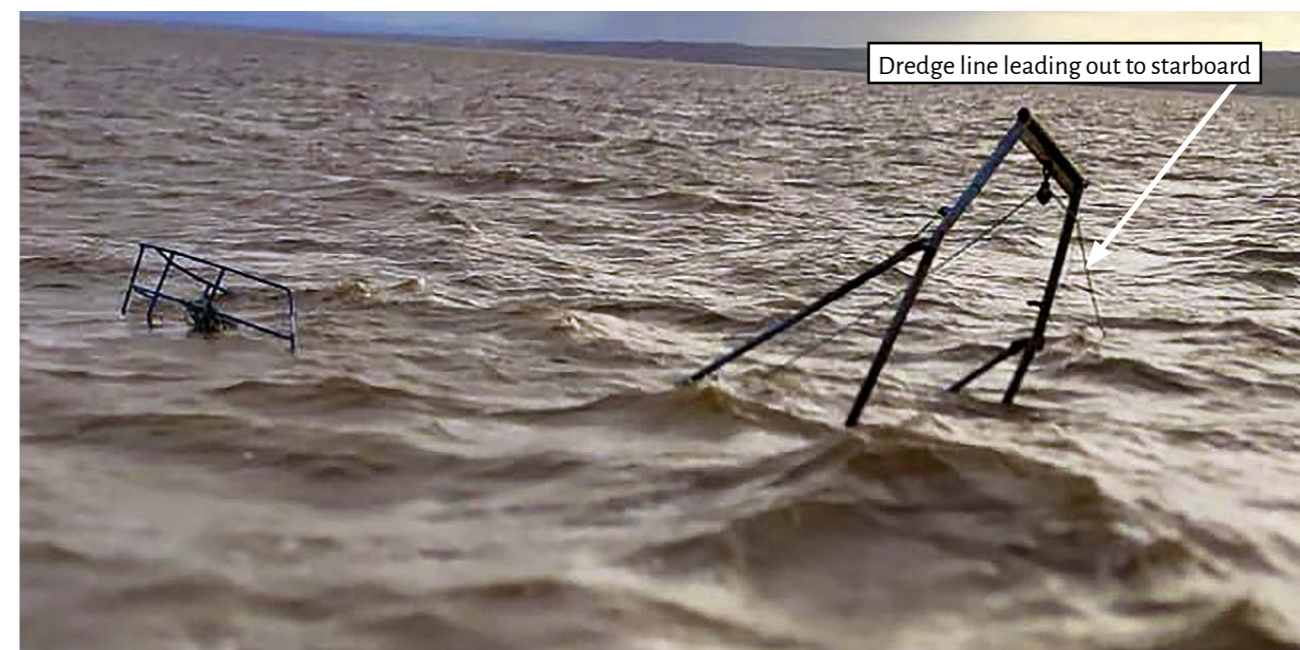
Figure 1: The dredger capsized to starboard with only the bow rails and dredging gantry visible

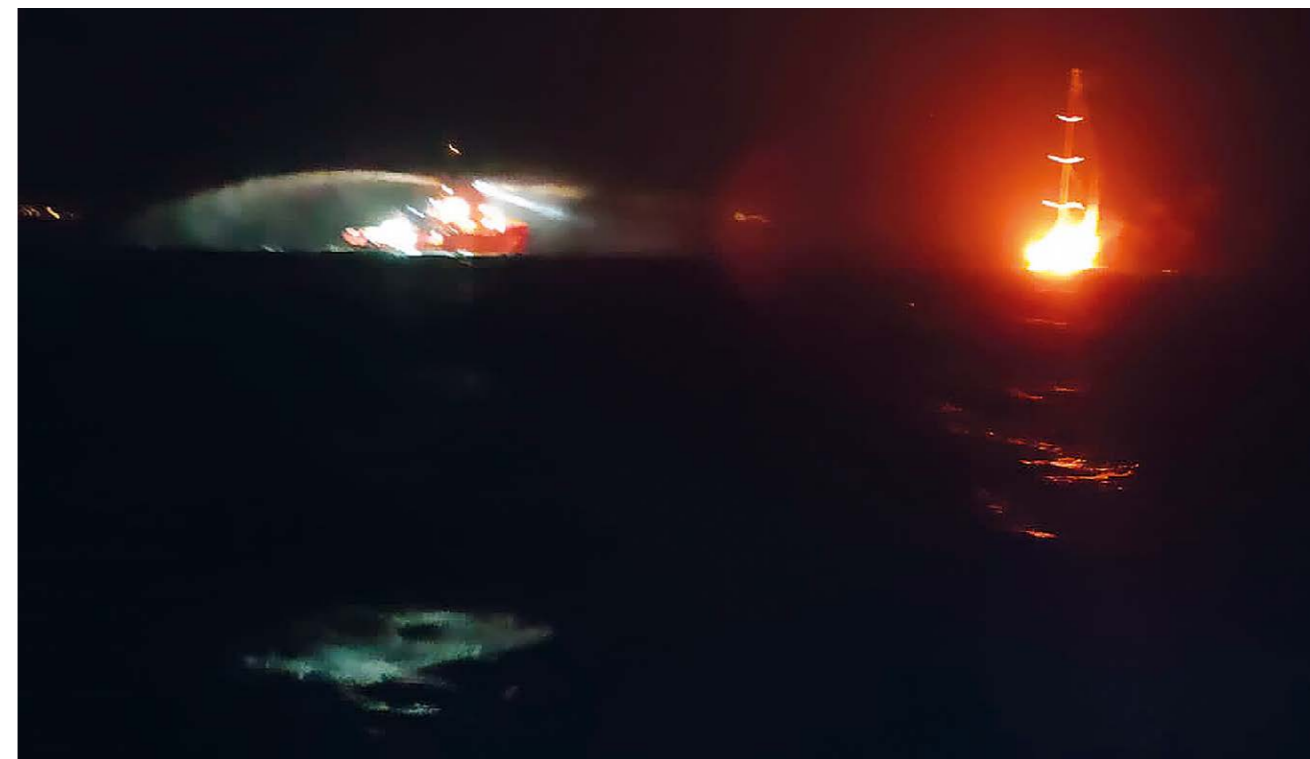
Figure 2: The fire takes hold, despite the best efforts of the rescue vessels

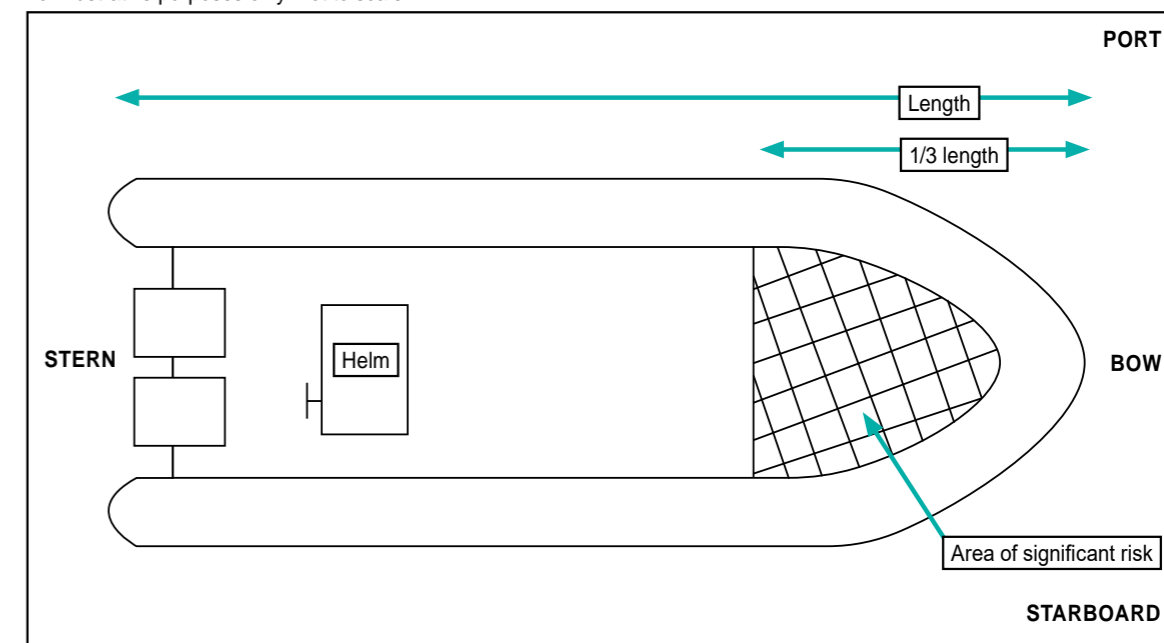
Figure 2: RIB outline highlighting the area of significant risk

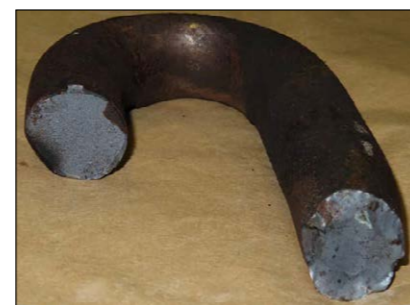
The ongoing MAIB investigation has found that a section of chain in the port dredging gear quick-release assembly failed as the gear was being retrieved. A 32mm chain link, which was led over a static steel pin at the derrick head (**Figure 1**), parted (**Figure 2**) and allowed the towing block, monkey face block and associated gear to fall to the deck below.

Figure 2: Failed chain link on *Honeybourne III*

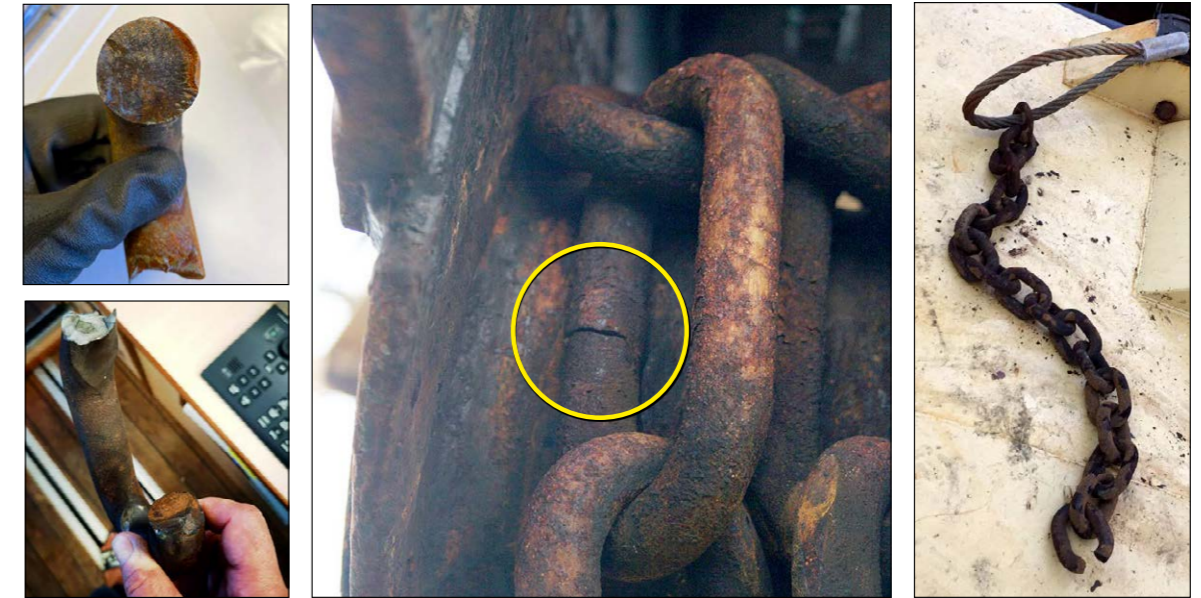
The configuration of a chain led over a static pin as part of a quick-release gear is commonly used on board scallop dredgers and beam trawlers. Such arrangements are known to have failed previously and chain fractures have been identified during routine inspections of quick-release gear (**Figure 3**).

Figure 3: Identified chain defects in static pin arrangements
