SAFETY DIGEST

Lessons from Marine Accident Reports

1/2024

MARINE ACCIDENT INVESTIGATION BRANCH

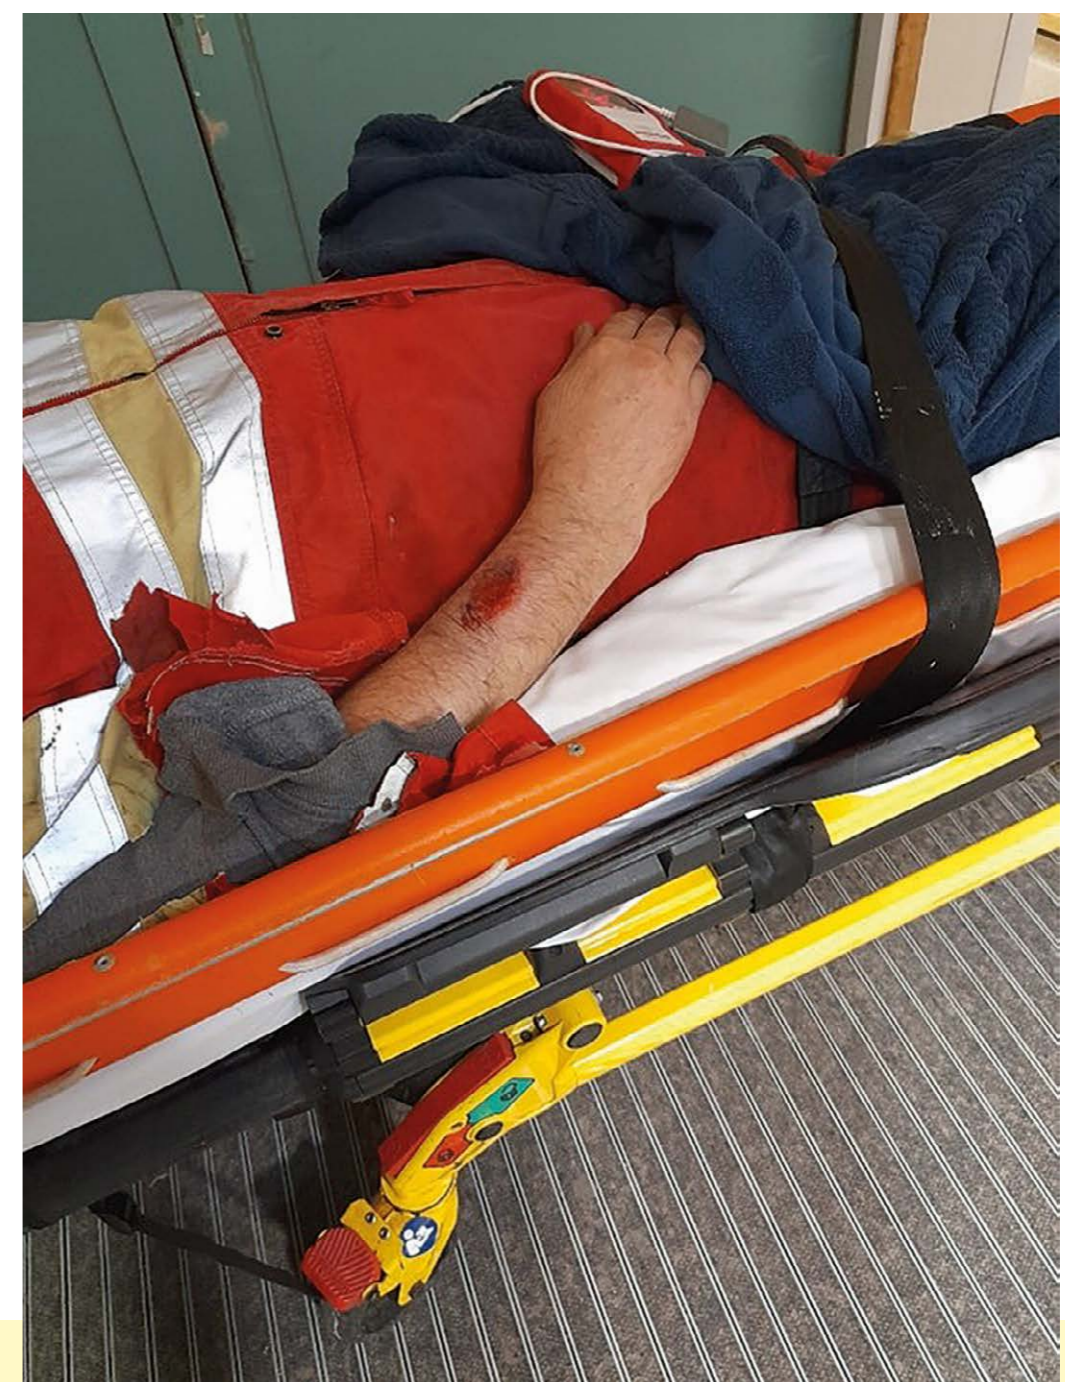
When the winch brake was released the tension in the line connected to the cargo barge caused the winch drum, and still attached cranking handle, to spin uncontrollably. The spinning cranking handle violently struck one of the crew members, fracturing their wrist and inflicting significant pain (Figure 2). The crew member was evacuated from the tug by a Royal National Lifeboat Institution (RNLI) lifeboat and

Figure 2: The crew member's fractured wrist

1. **Risk** → The pusher tug's crew might have identified the risk posed by the hazard of the still attached cranking handle had they collectively taken a moment to undertake a dynamic risk assessment rather than rush to complete the task. Empowering crew to identify hazards, assess the risks involved and report their concerns contributes to a proactive on board safety culture and reduces the likelihood of accidents.
2. **Monitor** → The master could not safely undertake the simultaneous tasks of steering the pusher tug and trying to control the aft deck operations from a position of limited visibility. The use of the closed-circuit television (CCTV) to provide operational oversight from a remote position can help to identify any safety issues and take immediate preventative action.

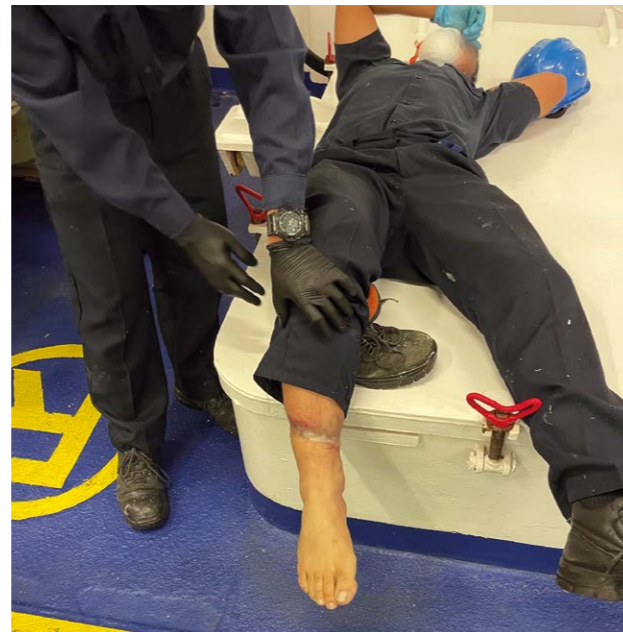
The AB was disentangled from the messenger line and immediately taken ashore for medical treatment for a broken shin bone and other leg injuries (Figure 2).

Figure 2: The AB's leg injury

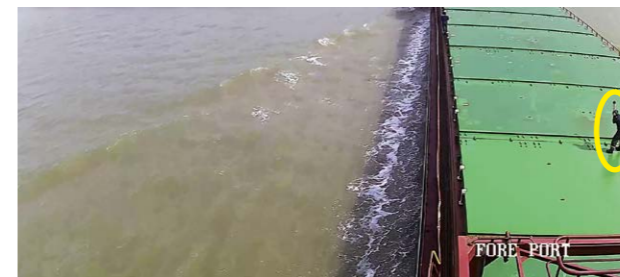
The crew member quickly approached the wedge and, without taking time to prepare, swung the sledgehammer (Figures 1 and 2).

Figure 1: Crew member swinging the hammer

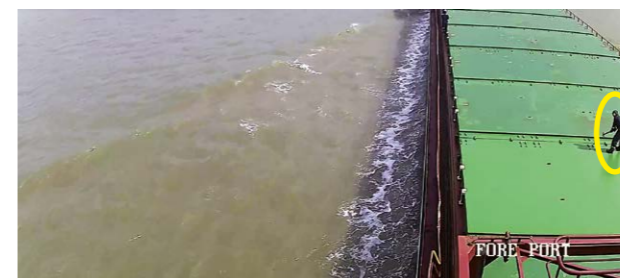
Figure 2: Bottom of the hammer swing before impact

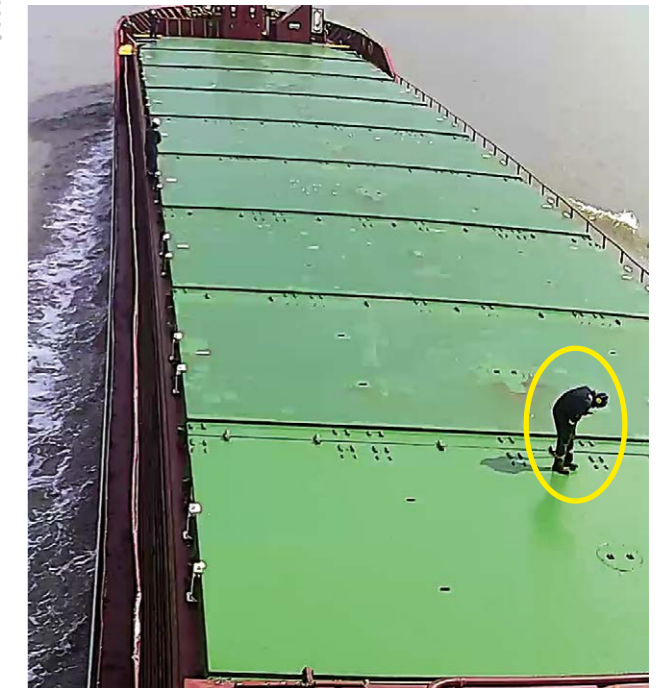
When the hammer impacted the wedge it remained lodged in place and shattered, sending debris flying towards the crew member. A small fragment of the securing wedge penetrated the crew member's right leg, just below the knee (Figure 3). The crew member received first aid and was signed off work for 3 days to recover from their injury.

Figure 3: The injured crew member

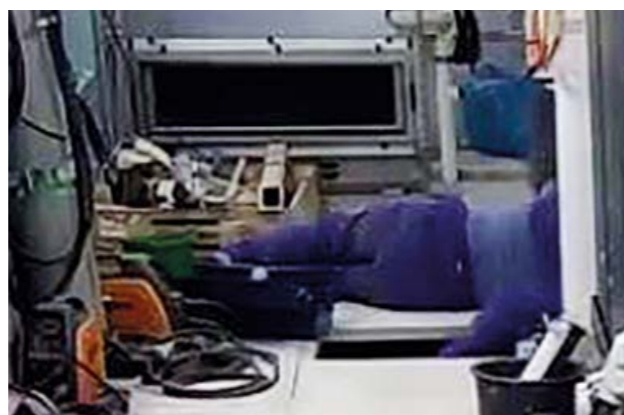
Meanwhile, the cruise ship began its scheduled departure in rippled sea conditions with the wind gusting to 30kts. Shortly after leaving its berth the vessel rolled slightly and the compressor tilted from its suspended position, crushing the contractor.

Figure 1: Contractor lying on deck to reach and disconnect mounts

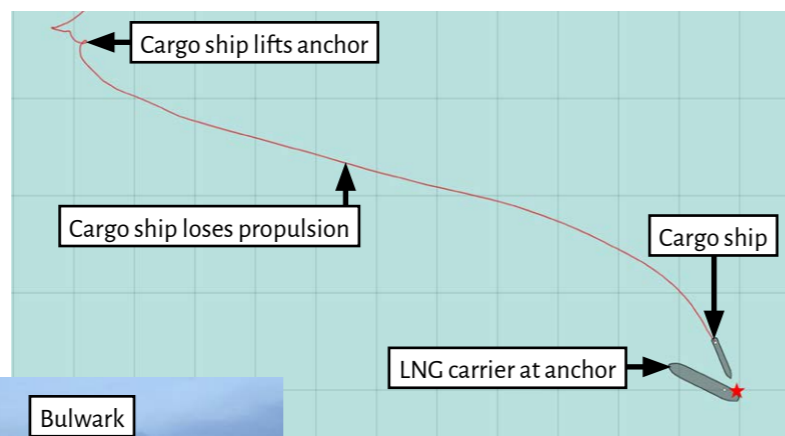
had stopped because the fuel supply pump had not been started up as the ship was prepared for departure. The engine had run just long enough on the fuel in the system for the ship to lift the anchor before it stopped.

Figure 1: Track of the cargo ship

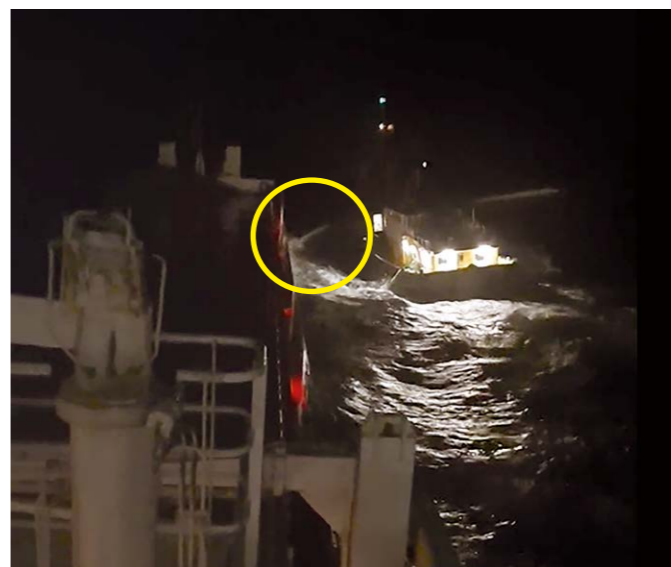
The OOW became aware all was not well and started to alter course to port but it was too late for the bulk carrier to avoid contact with the port derrick arm of the fishing vessel, which momentarily keeled over by about 15° (Figure 1) before it righted itself and passed clear down the starboard side. The fishing vessel limped back into harbour several hours later, hampered by its unrecoverable fishing gear. The crew were uninjured but there was substantial damage to the derrick's arm and posts (Figure 2) and the fishing gear was written off. The bulk carrier suffered plate and frame damage (Figure 3).

Figure 1: Video still showing the bulk carrier hitting the fishing vessel's deployed derrick arm

- Monitor** → Whatever the plan, it must be monitored throughout. The OOW became distracted by the other crew members watching a movie on the bridge, which resulted in a delayed reaction to the developing situation. The safety of the crew, the ship and other mariners relies on watchkeepers staying alert while on duty.

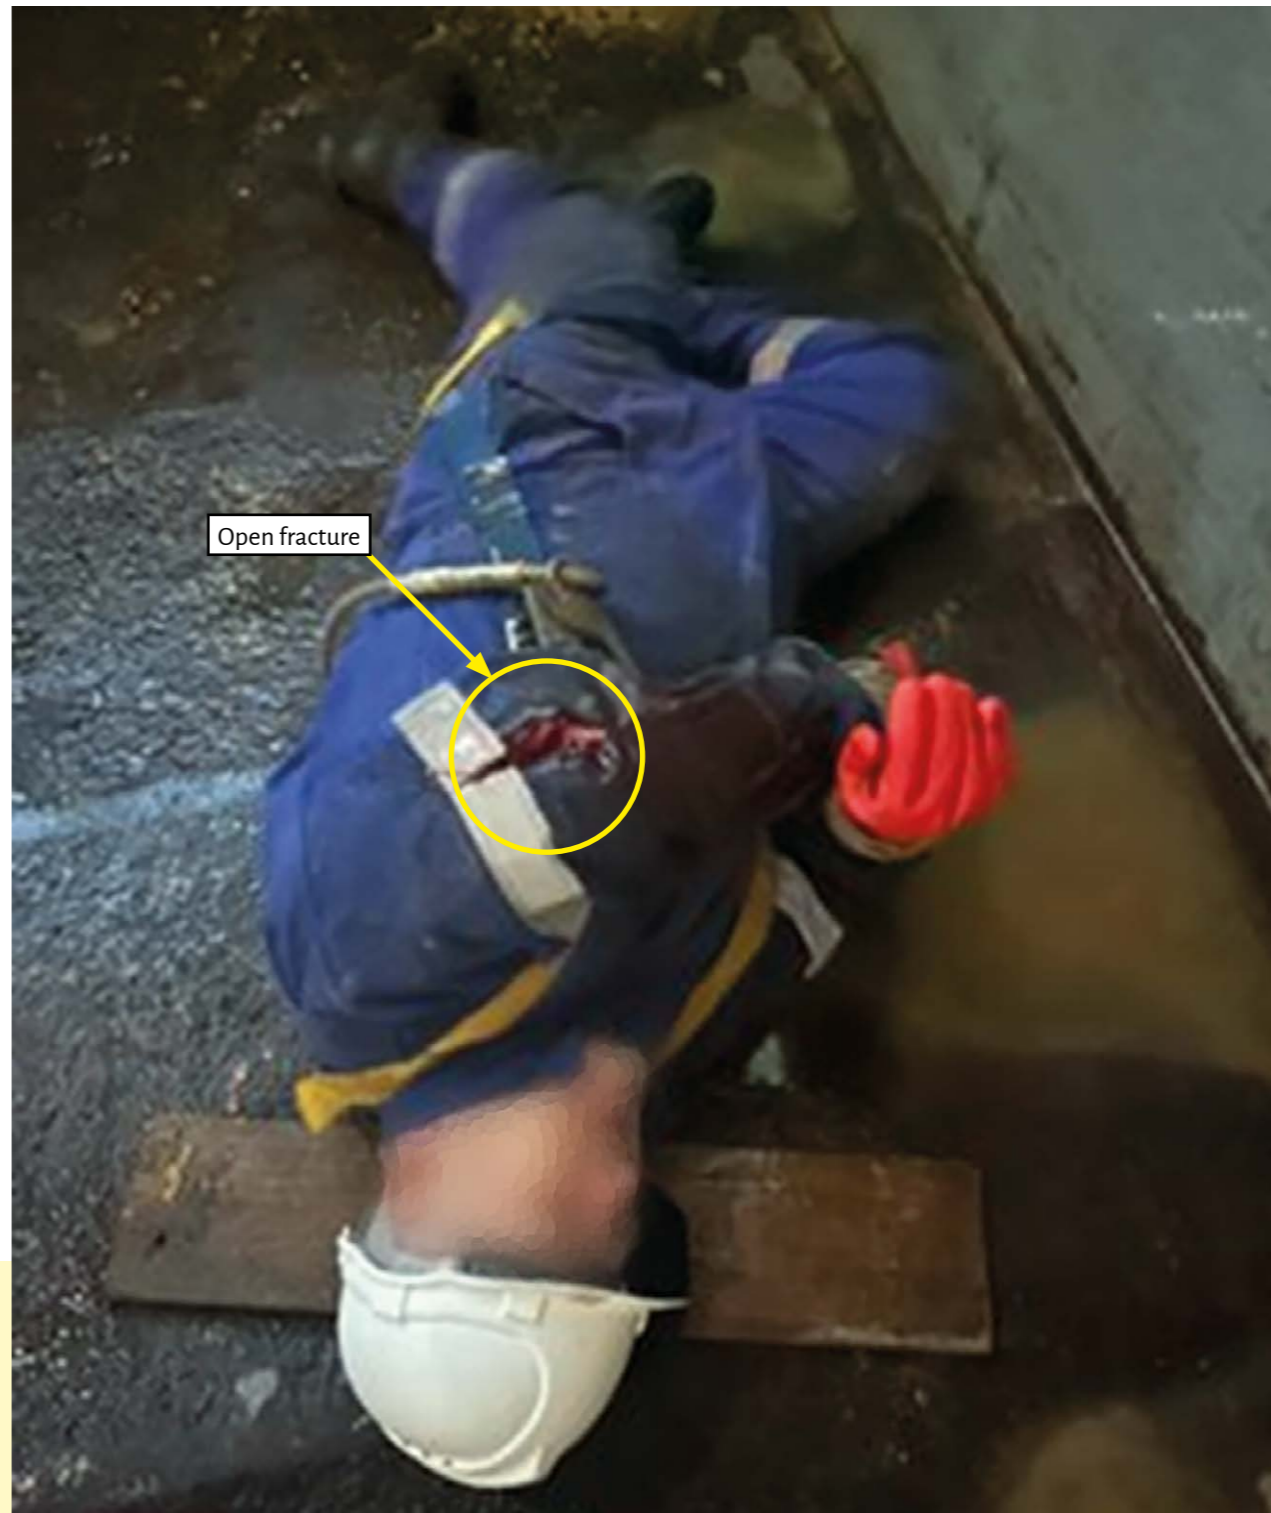
The ship's master called the emergency services and, due to the difficulties of lifting a casualty out of the hold bottom, medical attention was administered at the scene for over an hour before the AB could be recovered to a waiting ambulance and transferred to hospital for further treatment.

Figure 2: The injured AB lying in the hold

- Equipment** → The safety harness worn in this case was equipped with only one lanyard and hook, limiting the ability of the wearer to move around safely at height. Once the safety hook is disconnected to move to another locking point, the wearer remains at height without any fall arrest or fall prevention measures apart from hand and footholds; this might be unsuitable in the local conditions. A harness with twin lanyards and safety hooks enables movement at height while providing a means of fall prevention.

- Procedure** → The ship did not have procedures or equipment to recover an injured person from the cargo hold. Without suitable crew training and recovery equipment, it is possible for a survivable injury to become a fatality. Think about what could go wrong and then plan and be prepared to respond in the event that it does; it could be you lying at the bottom of the hold in serious pain.

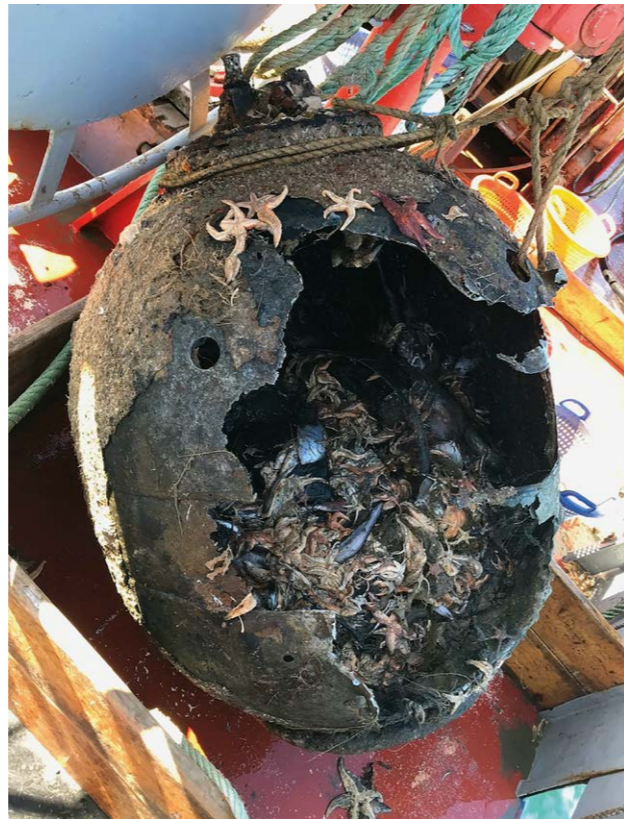
A Royal Navy Explosive Ordnance Disposal (EOD) team was tasked by the coastguard to attend and deal with the situation. On arrival, the EOD team identified some residual explosive material within the sea mine that could still be dangerous and proceeded to cut the sea mine free from the vessel's net, lower it carefully to the seabed and mark it with a yellow float.

Figure: A typical sea mine recovered from the seabed

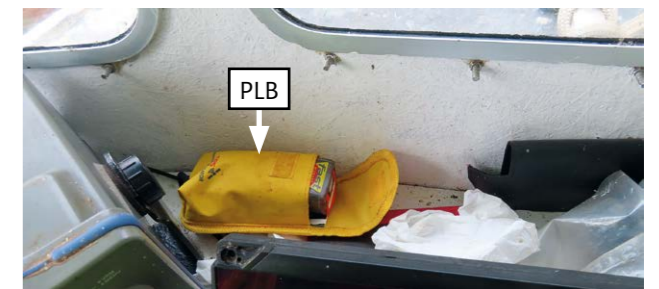
The skipper was able to free their foot from the gear, but could not catch up with the vessel as it motored away and had to fight to stay afloat in the water with no means to raise the alarm: the skipper was not wearing either a personal locator beacon (PLB) or personal flotation device (PFD), both of which were stowed in the wheelhouse (Figures 1 and 2).

Figure 1: The skipper's PLB

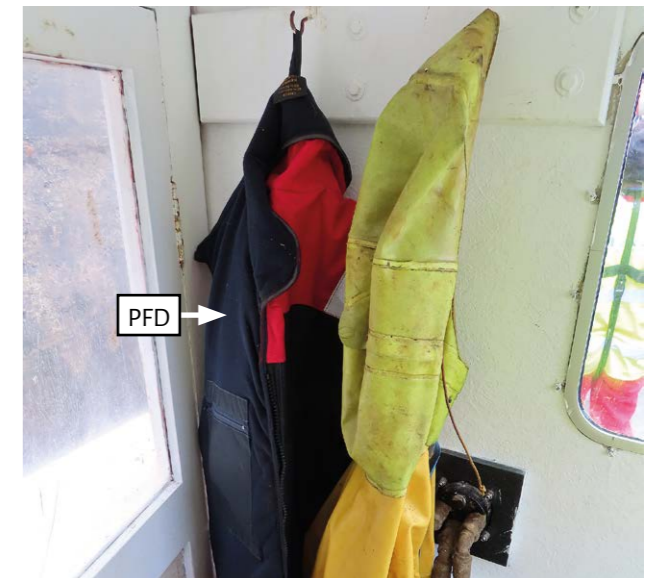
Figure 2: The skipper's PFD

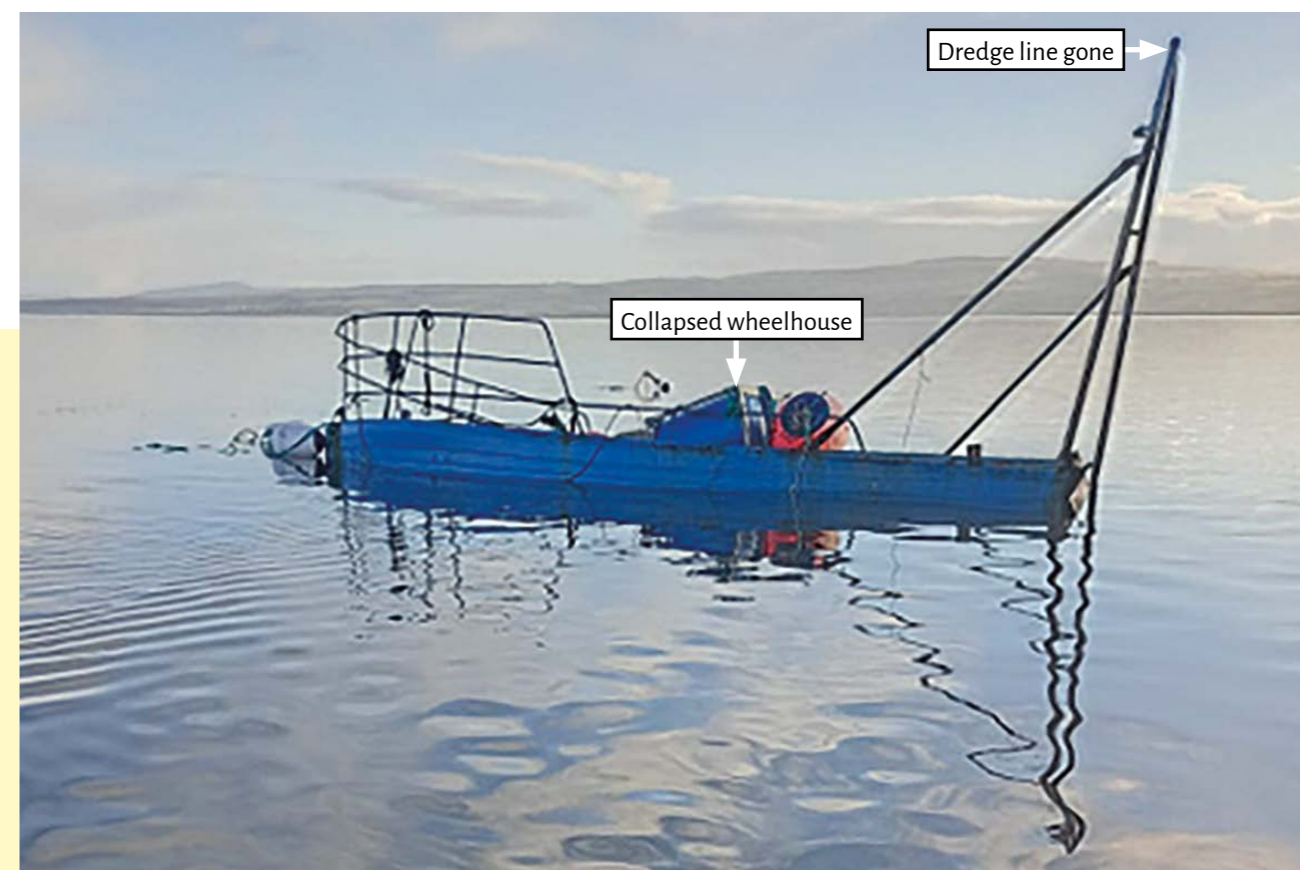
Figure 2: The dredger before recovery

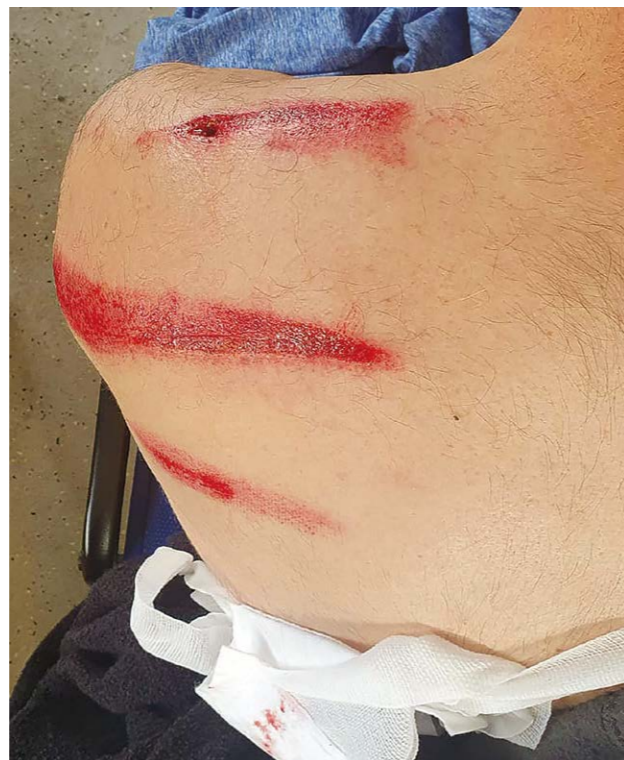
The instructor was standing next to the novice coxswain at the helm and another student was sitting on the starboard sponson towards the stern. The novice coxswain conducted the drill as instructed, but as the boat turned sharply to port the student on the sponson fell into the water and was struck on the shoulder by the propeller (see figure).

Figure: The student's injuries

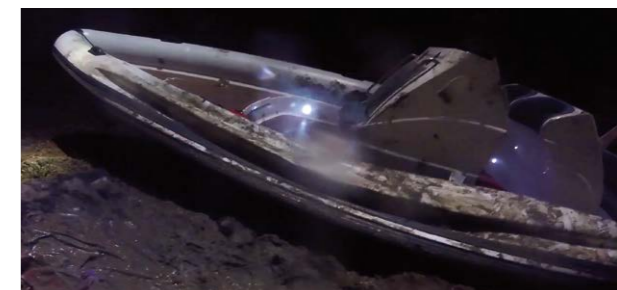
The RIB was driven at high speed and the driver did not use the on board plotter to guide the craft's track. On approach to the marina the driver made a turn to follow the channel when, without warning, the RIB stopped. The fast deceleration caused all the occupants to be thrown forward, one of whom suffered a back injury. The RIB had grounded at high speed on mud flats at the entrance to the channel (Figures 1 and 2). One of the group raised the alarm by using VHF radio to call the coastguard and two RNLI lifeboats, a coastguard rescue helicopter and emergency ambulances were immediately tasked to the scene.

Figure 1: The RIB on the mud flat

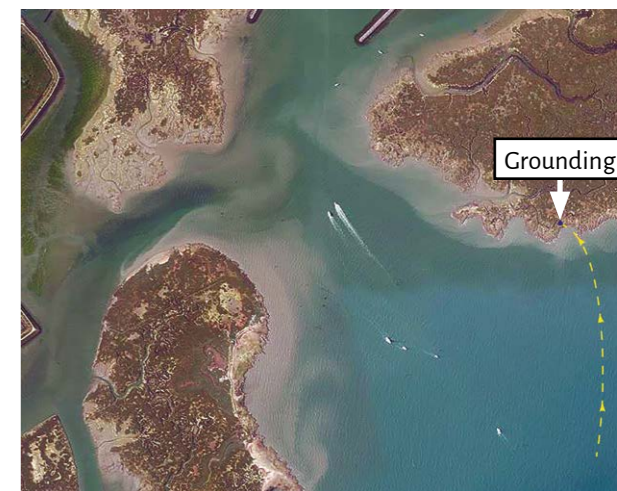
Figure 2: Aerial view of the RIB's predicted track to its place of grounding on the mud flat

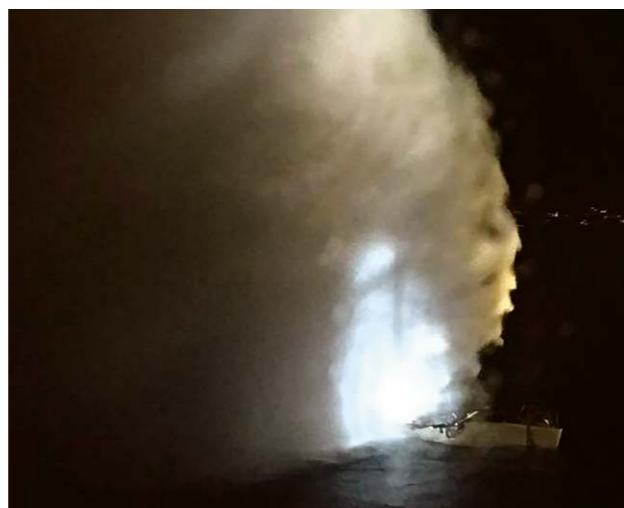
The coastguard arrived 45 minutes later, by which time a fourth small fire had been extinguished and the crew had retreated to the upper deck due to smoke inside the yacht's cabin. The coastguard started to tow the yacht but yet another fire started around 30 minutes before arrival into port, this time engulfing the yacht. The crew were beaten back by clouds of thick smoke (Figure 1) and evacuated to the attending rescue vessel.

Figure 1: Smoke envelops the yacht, forcing the crew to evacuate

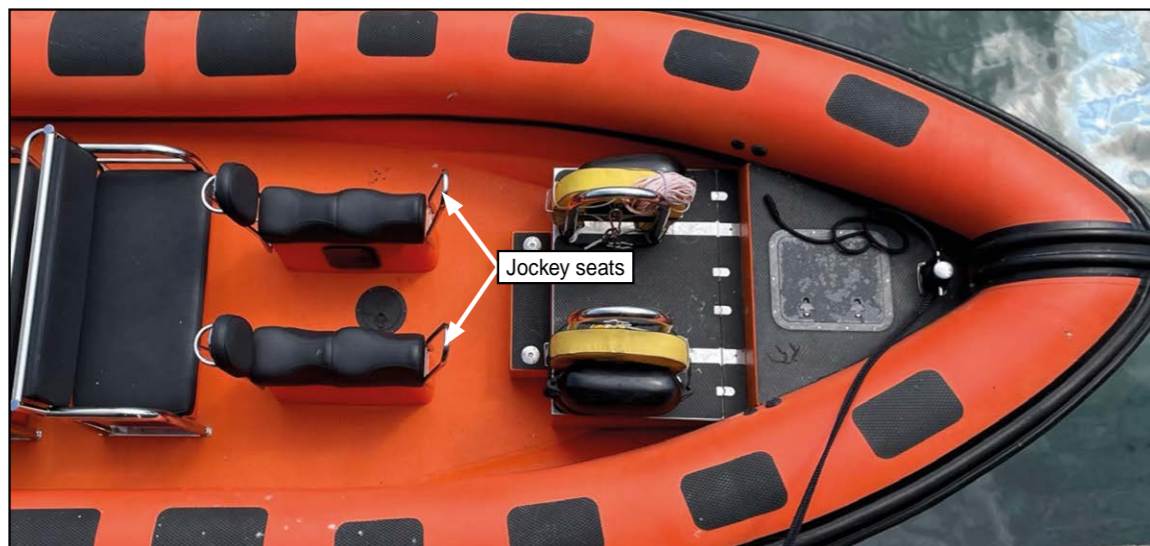
On 7 June 2023, a passenger on a rigid inflatable boat (RIB) sea safari suffered a spinal injury that left them paralysed from the waist downwards. Twelve passengers had boarded the RIB and, once it was clear of the jetty, the two crew gave them a safety briefing and instruction on the wearing of lifejackets. The RIB then proceeded out to sea and was increasing speed in choppy sea conditions when it encountered a steep-sided wave. The boat fell off the wave and slammed violently into the trough, dislodging a passenger from a forward jockey seat (**Figure 1**). The passenger immediately lost feeling in their legs.

Figure 1: Front of RIB with jockey seats

The accident happened in weather conditions that the skipper considered favourable for the trip. Although the RIB was not travelling at high speed, as the bow pitched up on encountering waves it restricted the skipper's view ahead. The steep-sided wave caught the skipper unaware and without time to mitigate the impact.

When the boat hit the trough, the resulting force applied to the passenger's spine was of sufficient magnitude to fracture a vertebra. With a normal BMD level and no pre-existing conditions to increase their susceptibility to this type of injury, the factors contributing to the fracture related to the activity being undertaken. These included:

- the speed and movement of the RIB in the sea conditions
- the forward location of the seat that the passenger was using
- the passenger's seated posture and their ability to react and compensate for the RIB's motions
- the passenger's awareness of the hazards associated with the RIB's movement.

There is a significantly higher risk of spinal fractures to people seated in the front area of RIBs, regardless of speed.

- Urgently review their operations and risk assessments, with reference to the CoP and MGN 436 (M+F). This review should assess and mitigate the risks associated with the requirement to seat passengers in the front area of a RIB and ensure that the risk assessment includes and addresses the variability of weather conditions and the ability of passengers.
- Review their passenger pre-departure briefing and ensure that it includes a specific explanation of how to use the seat(s) and their associated handholds, including how to maintain the correct posture and stability to mitigate against injury.

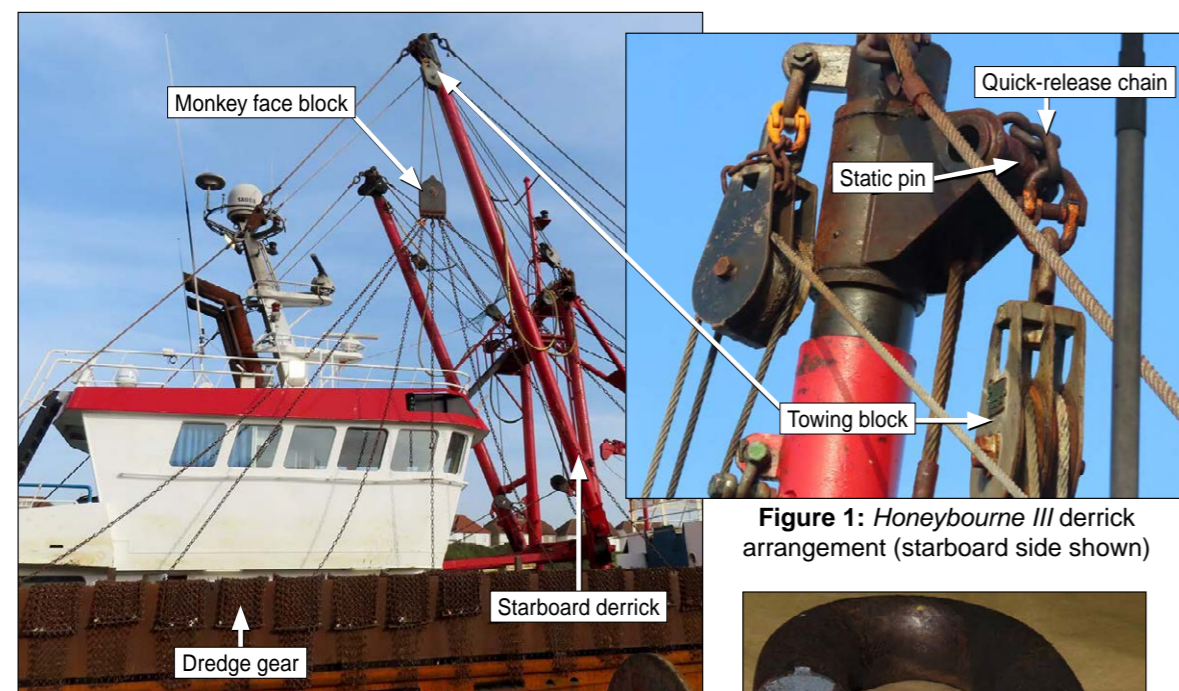
The ongoing MAIB investigation has found that a section of chain in the port dredging gear quick-release assembly failed as the gear was being retrieved. A 32mm chain link, which was led over a static steel pin at the derrick head (**Figure 1**), parted (**Figure 2**) and allowed the towing block, monkey face block and associated gear to fall to the deck below.

Figure 1: *Honeybourne III* derrick arrangement (starboard side shown)

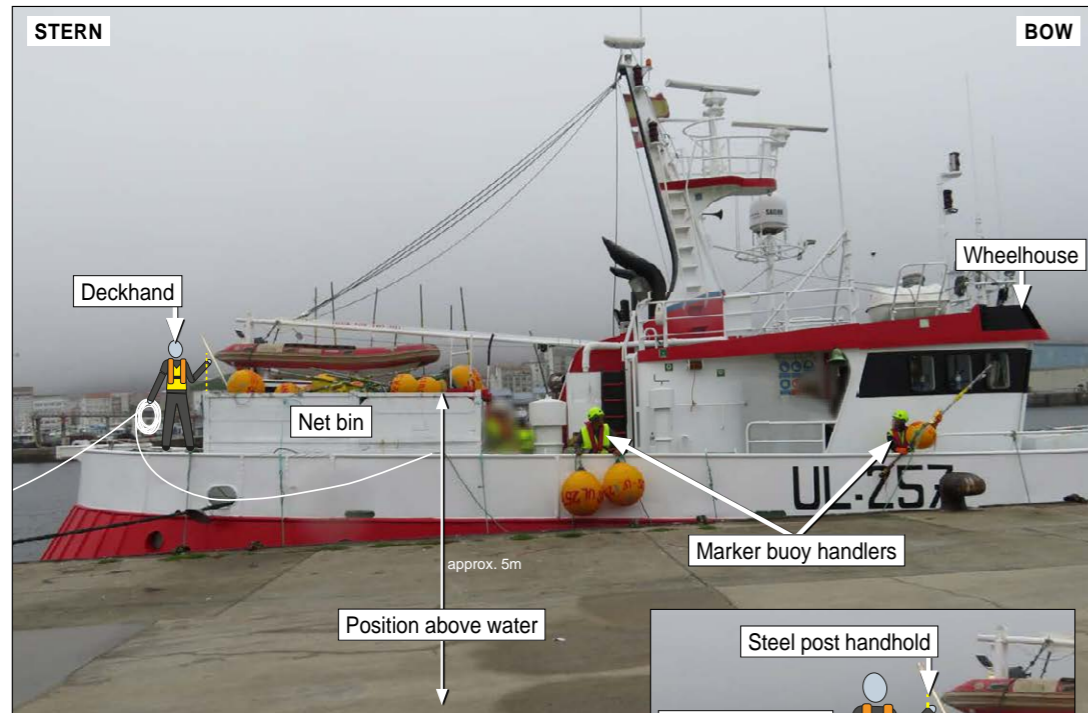
For illustrative purposes only: not to scale

Reconstruction, showing the positions of the deckhands during the final phase of shooting the net
